Cloudman Bay-Bligh Is., PWS-NE06

Geographic Response Strategies for Prince William Sound Subarea

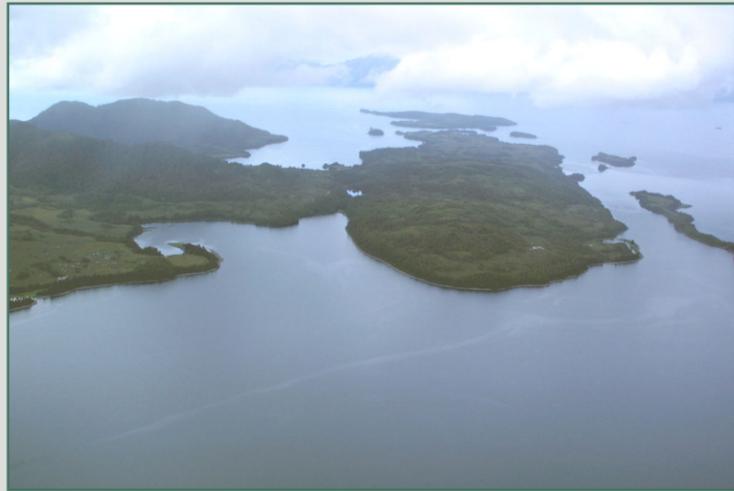
NE-06 Cloudman Bay viewed from the southeast.

NE-06-01 Cloudman Bay viewed from the southeast.

NOTES:
 Site is used for Aquaculture nets moved from West Tatitlek Narrows.
 Boom deployment can be altered depending on localized weather conditions.

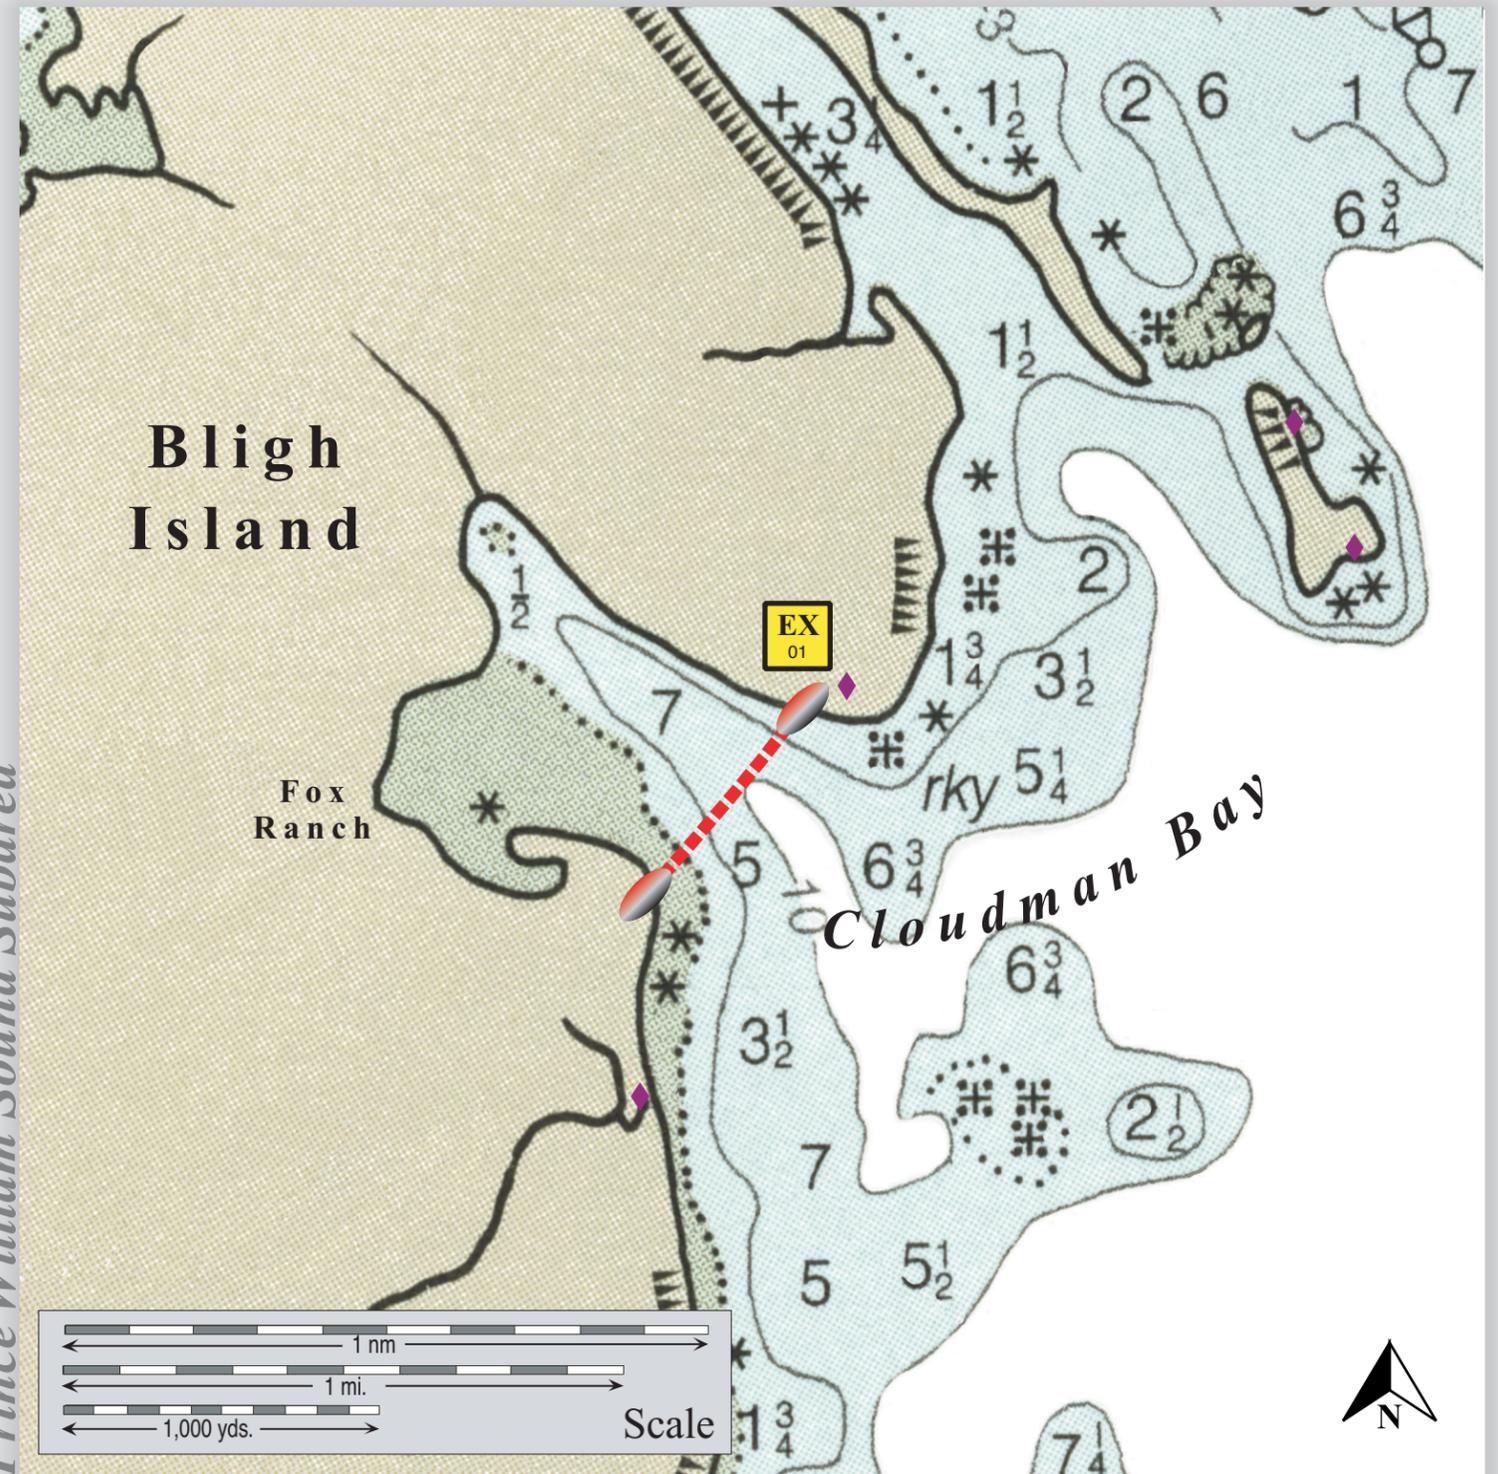
Center of map at 60° 50.23' N Lat., 146° 43.23' W Lon.
